Interim Report

Survey and Investigation of Buildings Damaged by Category III, IV and V Hurricanes in FY 2022-2023

Hurricane Idalia - 28 August 2023

17 October 2023

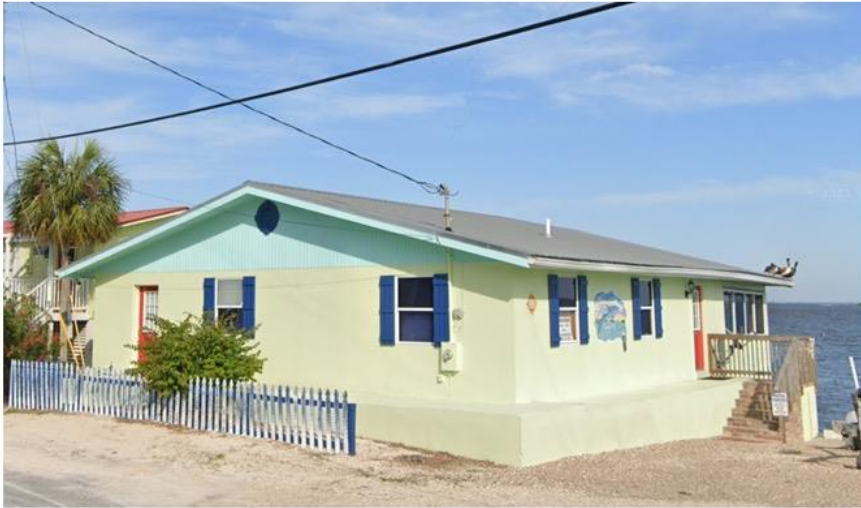
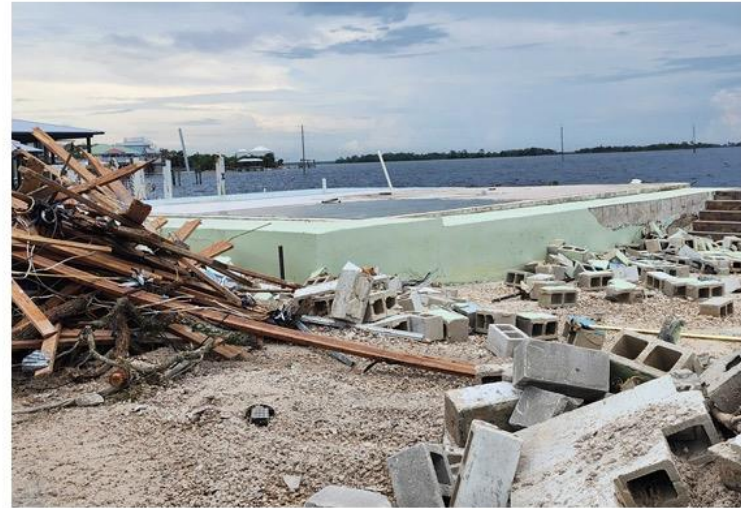
Case Study - #1

Complete destruction of single-story, concrete masonry home constructed in 1970.
(Horseshoe Beach, FL)

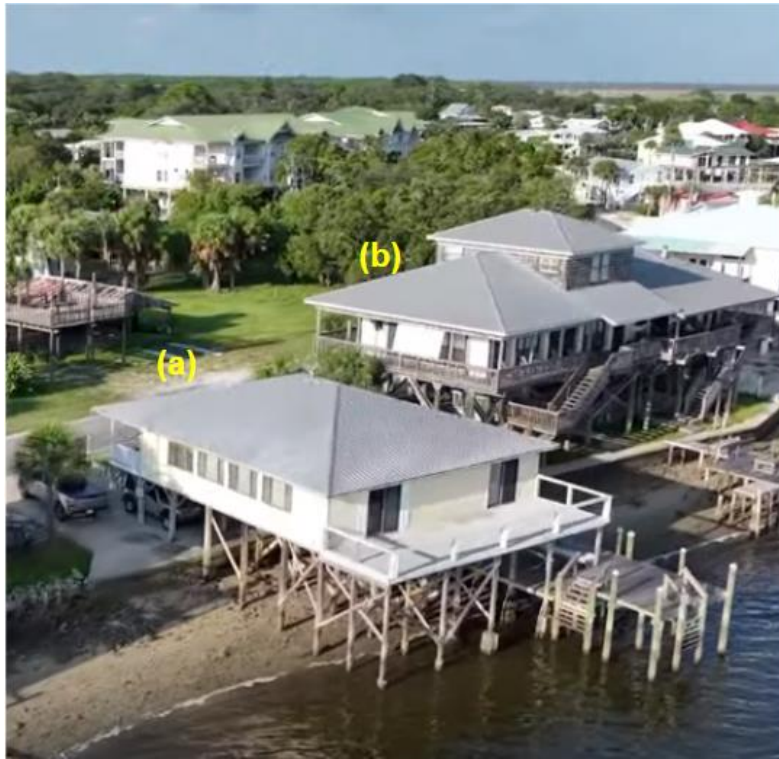
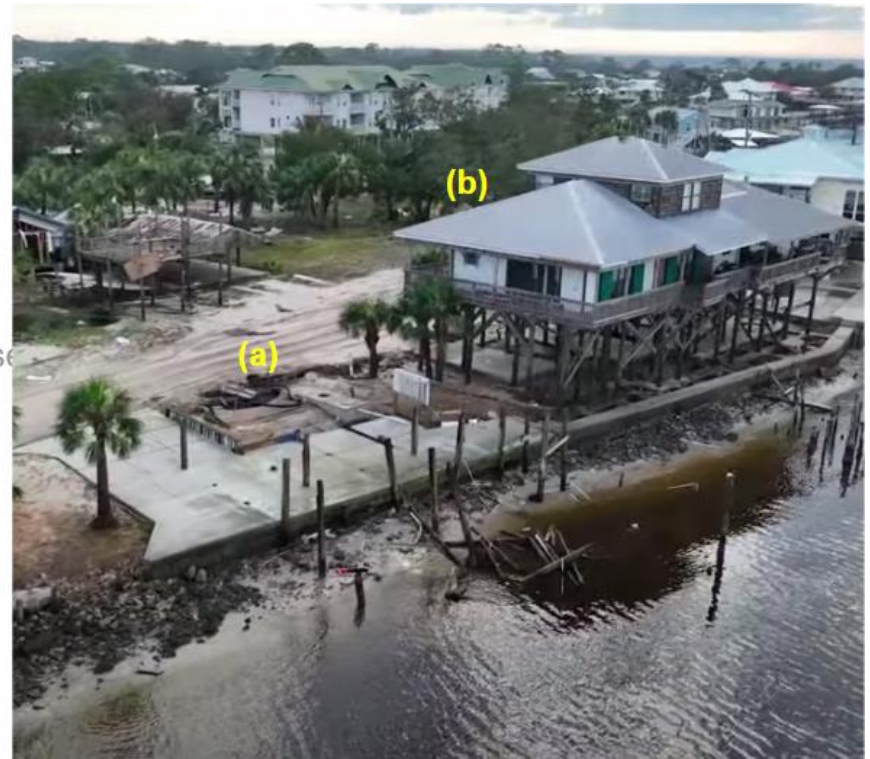
Case Study - #2

Complete loss of a building (a) in Horseshoe Beach, FL. Failed (broken and withdrawn) foundation members (piles) can be seen. Home was built in 1937 and was elevated ~6 ft above grade. Building (b) was constructed in 1994 and elevated ~10 ft above grade.

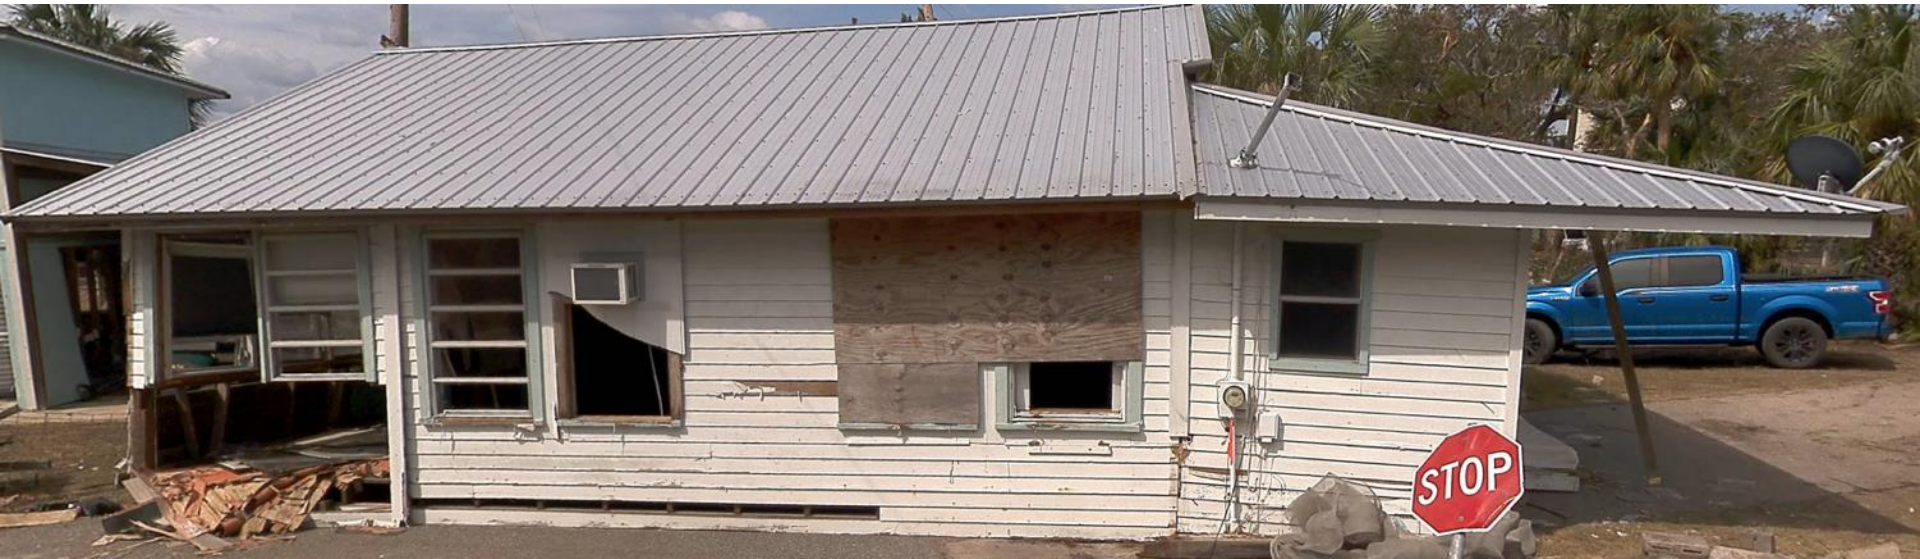
Case Study - #3

Wall and window damage likely due to surge (Horseshoe Beach, FL)

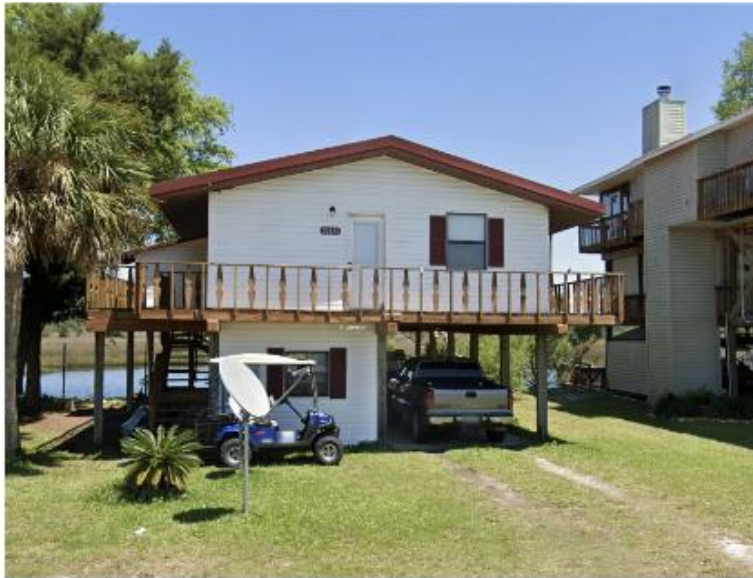
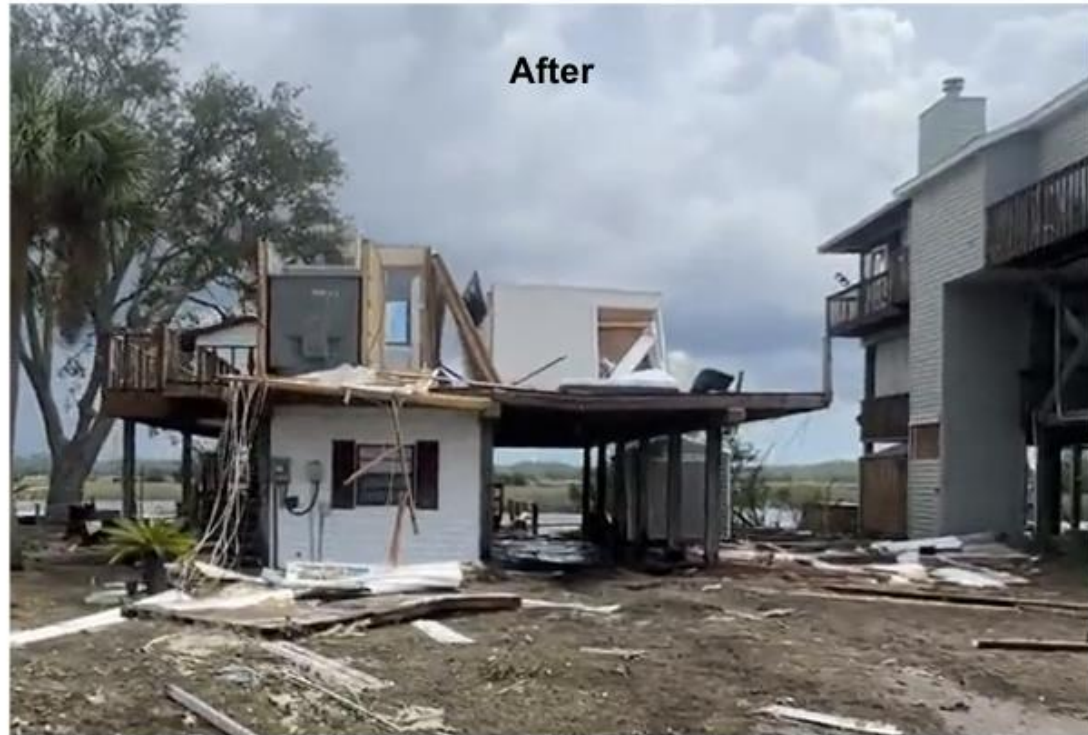
Case Study - #4

Structural roof damage to a wood-frame home constructed in 1982, elevated approximately 7 ft above grade. An adjacent home, constructed in 1994, only suffered minor wall cladding loss. (Keaton, Beach, FL)

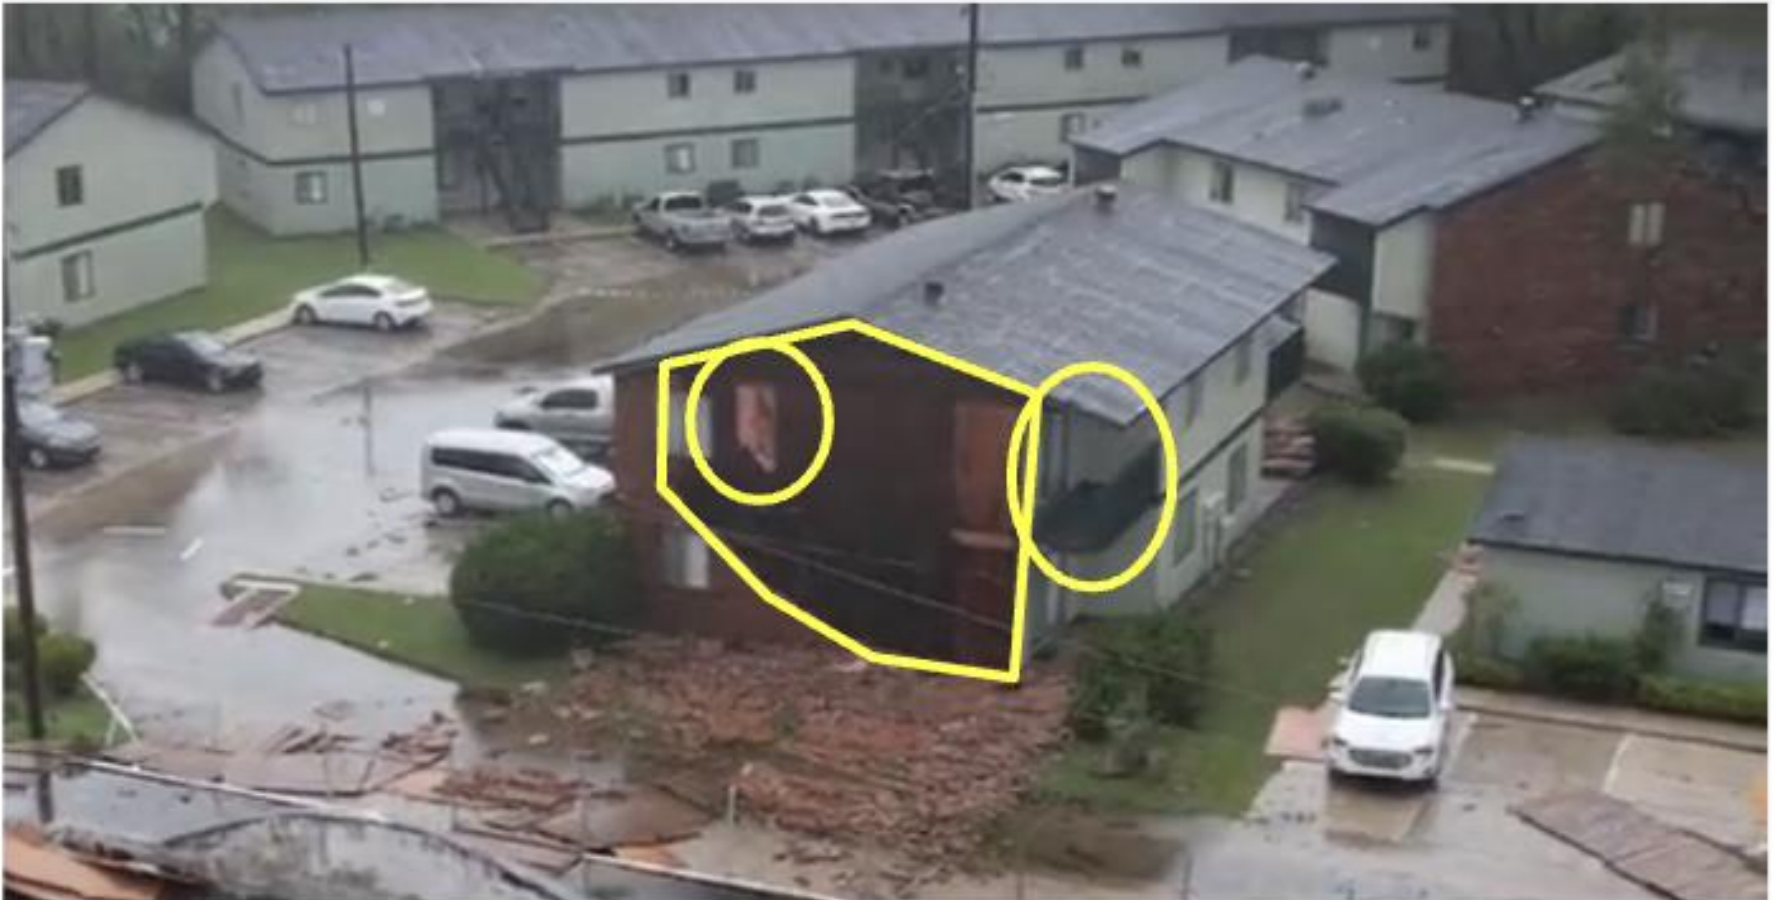
Multi-family Dwellings

Extensive facade (brick) damage, limited sheathing damage exposing insulation, and loss of balcony end wall on an apartment building in Perry, FL.

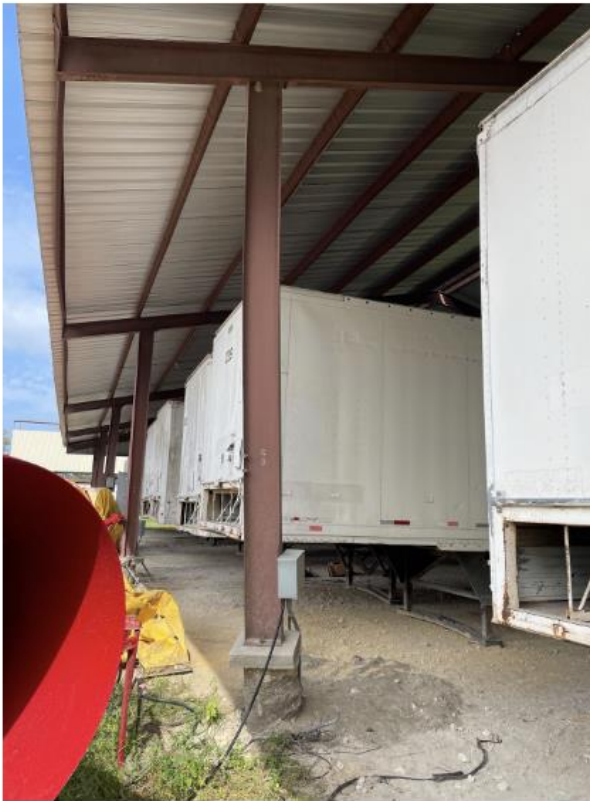
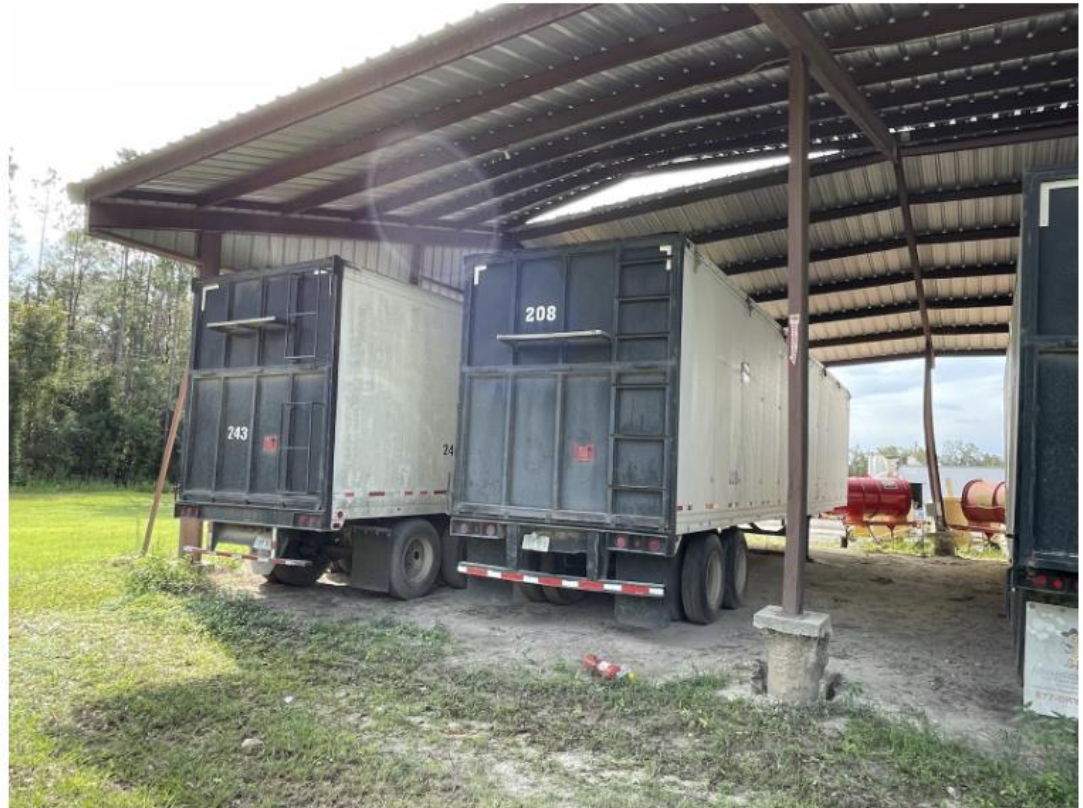
Farm Buildings

Column-foundation pull-out capacity failure.(Source: UF Triage Assessment).
