Interim Report

Survey and Investigation of Buildings Damaged by Category III, IV and V Hurricanes in FY 2022-2023

Hurricane Idalia - 28 August 2023

17 October 2023

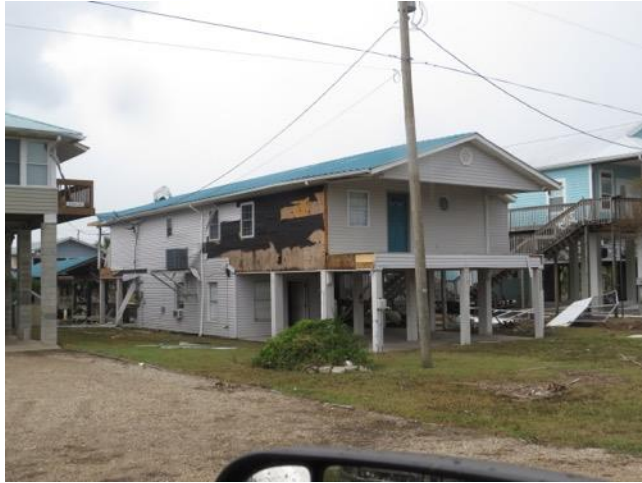
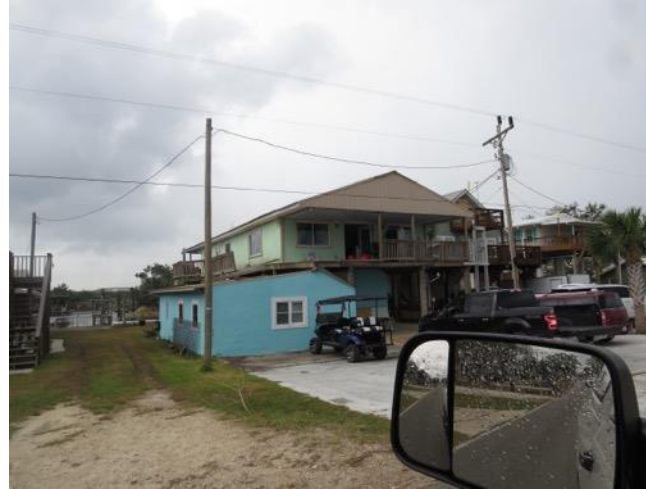
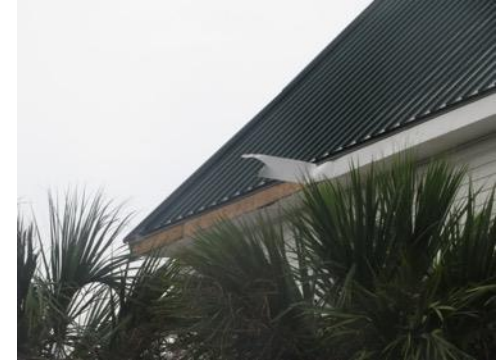
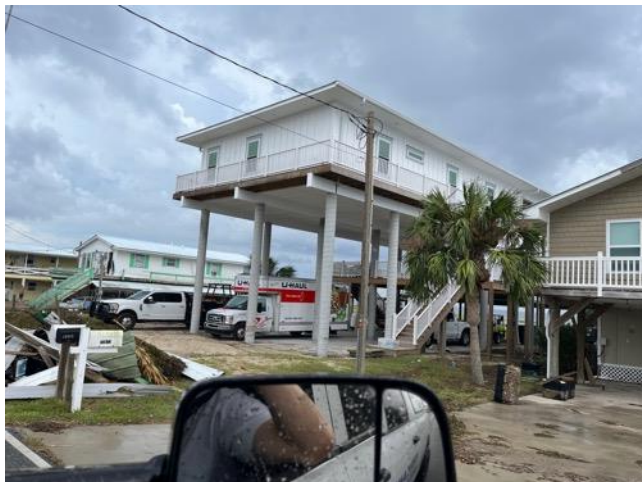
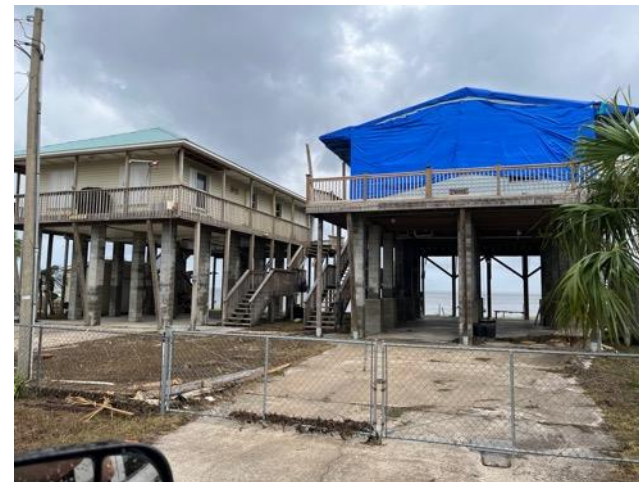
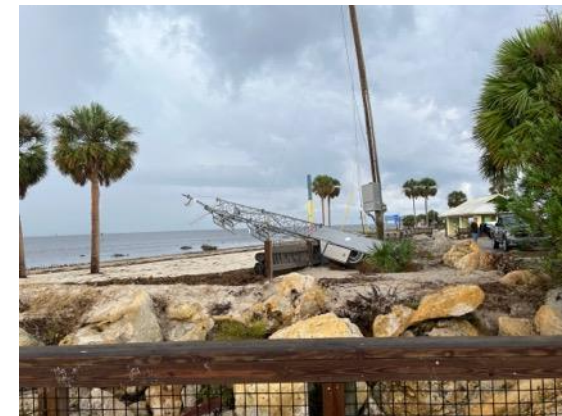
Keaton Beach

- Primarily loss of roof cover (shingles or old metal roofs)
 - Most structures had little to no observable roof cover loss
 - Roof cover loss was almost exclusively to older buildings
 - All elevations of subject buildings typically not available, so unseen damage is very likely
- Debris impact damage evident
- Window damage was observed. Pressure vs debris not assessed
- Roof decking damage was observed but infrequent, and only older construction

Overall observation is that coastal wind damage is consistent with that expected for a Cat 1-2 event, but it is much less frequent or severe than Cat 3 expectations. (This is independent of any storm surge damage)
